## **RADIOLOGICAL SAFETY IS A GROWING CONCERN: AN INCLUSIVE REVIEW IS DONE GIVING EMPHASIS ON COMMONLY PERFORMED RADIOLOGICAL EXAMINATIONS IN BANGLADESH.**

**M. Haider<sup>1</sup>, A.Aktar<sup>2</sup>, R.A. Amiree<sup>3</sup>, Y.N.Jolly<sup>4</sup>**

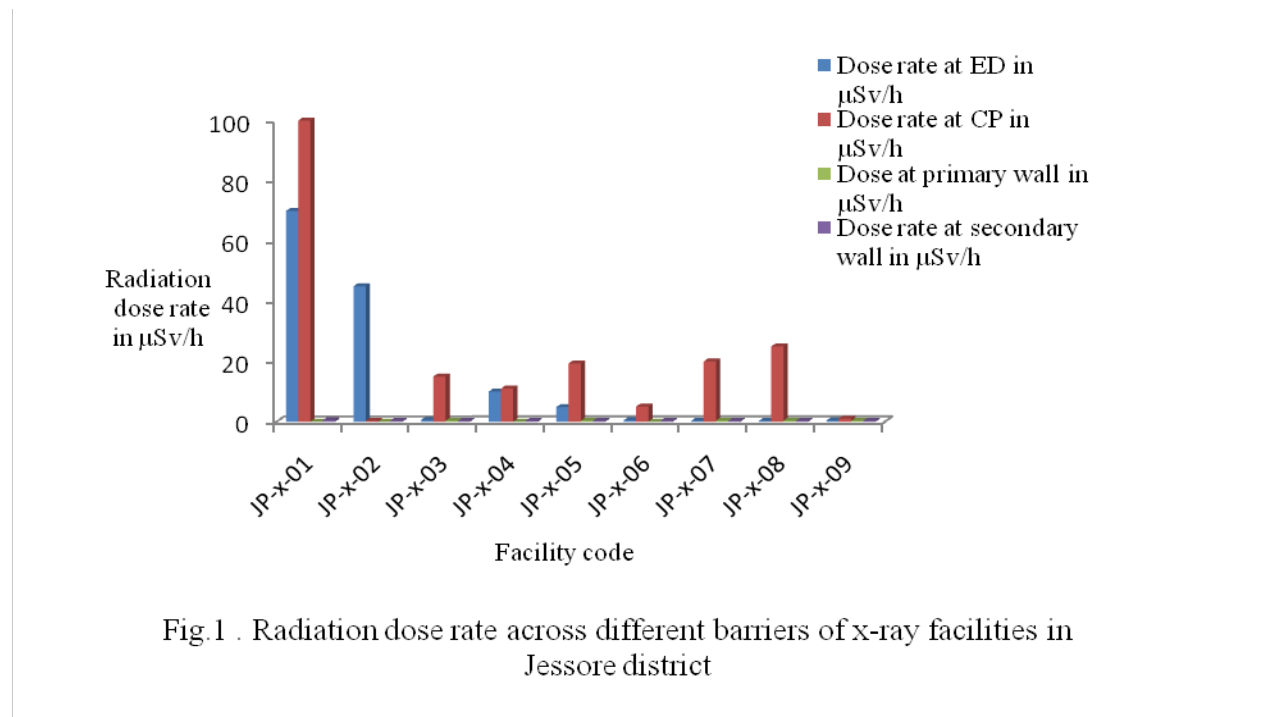
General observations about the radiation safety issues in the radiology facilities in Jessore district in Bangladesh are not quite up to standard. Fig1.represents radiation dose rates at different locations of diagnostic x-ray facilities. It shows that public receives radiation dose level in 06 facilities more than their permissible limit ( $0.5\mu\text{Sv/h}$ ) out of 09 facilities studied in the present work. The highest dose rate is recorded at entrance door (ED)  $70\mu\text{Sv/h}$ . During operation of x-ray machine, occupational workers were also exposed to radiation level which is adequately higher than their limit. Operating x-ray machines in 09 radiological facilities, occupational workers exposed to more than their limit in 06 facilities and the maximum dose received by them  $100\mu\text{Sv/h}$  which is 10 times higher their permissible limit ( $10\mu\text{Sv/h}$ ) according to national standard.<sup>8</sup>.

Fig.1 . Radiation dose rate across different barriers of x-ray facilities in Jessore district

The undesired amount of radiation doses might have been recorded in different locations in and around the facilities due to many reasons for example chest stands are not appropriately located, patient waiting areas are not adequate or provided properly, any types of caution symbols are seldom displayed, protective equipments are not available and most importantly the shielding structure of control panel (CP), entrance door (ED) and the surrounding walls of x-ray room don't comply as well with minimum standard of regulatory requirements.<sup>7</sup>.

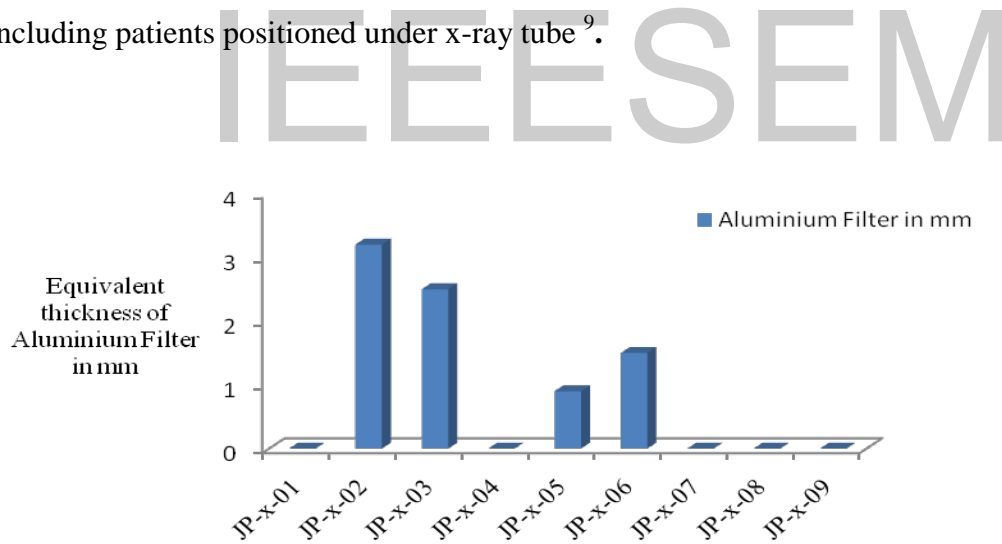
Fig 2. Facility Code

Fig.2 is representing equivalent thickness of aluminium in mm in x-ray tube. According to national standard, the minimum required thickness is 1.5 mm Al<sup>4</sup>. But the present study highlights, most of the facilities do not implement regulatory standards. It is worth mentioning that in the old Chinese machines having inputs parameters less than 50 mA usually lacking aluminium filters which is the most important part of x-ray tube to ensure filtered out low energy x-rays that doesn't contribute producing diagnostic image rather than contributing extra exposure to patients <sup>4</sup>. Furthermore, faulty design of old x-ray tube housing allows leakage radiations to spread out in the x-ray room which provides unwanted radiation dose to occupational workers including patients positioned under x-ray tube <sup>9</sup>.

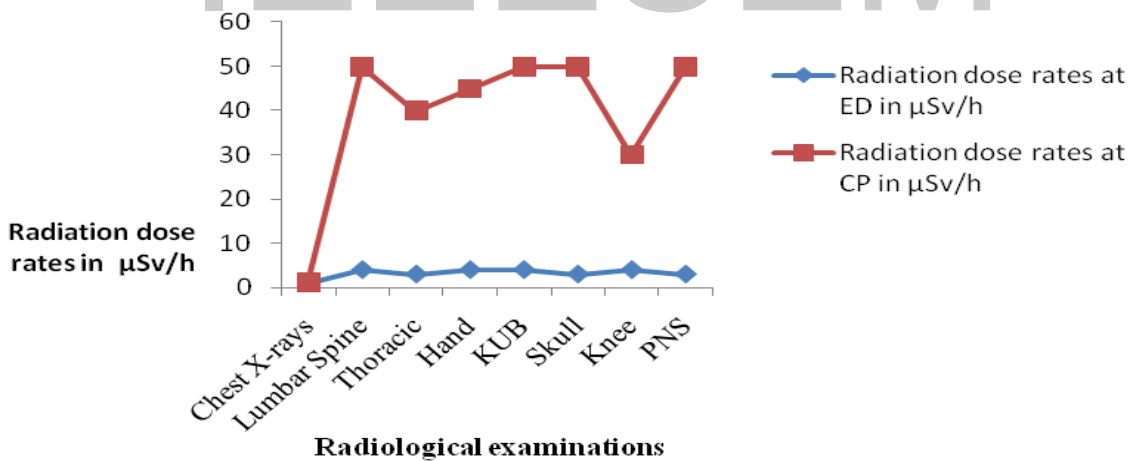
In Bangladesh there are 09 radiological x-ray examinations most commonly carried out by conventional x-ray machines according to the demand of referring physicians for investigating any fracture occurred in internal organs. Fig.3 depicts the analysis of radiation dose level during

delivery of exposure to patients for various diagnostic imaging studies based on the selection of machines inputs (mA, kVp & time) parameters. According to study, during diagnostic imaging of lumbar spine (LS), occupational workers exposed higher amount of radiation than the other examinations. The LS imaging requires larger machines' input (kVp) depending on the patient size. X-ray operator were exposed up to 50  $\mu\text{Sv/h}$  during LS study and hence if an x-ray operator runs a machine for large number of patients every day obviously he will be in risk from radiation safety point of view<sup>10,11</sup>. With regards to other imaging studies including KUB, Skull and PNS also provide higher amount of exposure to operators which is totally unexpected. Here it should be mentioned that sometimes lack of operator' education and skill they frequently make mistake to select proper input parameters of machines to deliver exposure which is ultimately increasing considerable amount of radiation levels in and around the facility. In the present study, only 03 x-ray operators out of 15 comply with regulatory requirements having three years diploma degree and necessary experiences to operate machines. Appointment of a radiation control officer (RCO) is another vital requirement for supervision of radiation safety matter in an x-ray facility but here in Bangladesh in most of the facilities x-ray operator is playing role as a RCO which straightforwardly violates the standards.<sup>12</sup>.

**Fig.3. Dose rate variations with radiological examinations performed in Cox's Bazar district**

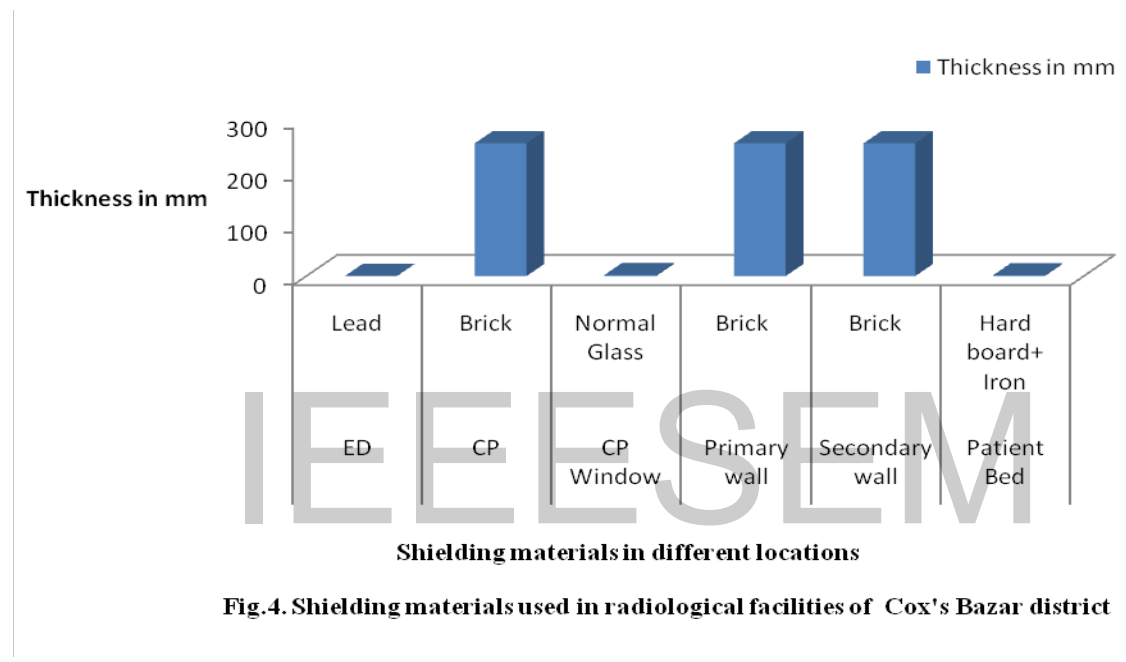
Fig.4. provides necessary information highlighting shielding materials most frequently used in the radiological facilities of Cox’s Bazar district. Due to lack of knowledge, some radiological facilities they are using non Pb based shielding materials without following any standard and this material couldn’t play any role to protect radiation level from penetrating through different barriers established in the facilities. Sometimes they are using recommended shielding materials but missing proper equivalent thickness of lead. In addition, the materials chosen by themselves were also found useless to ensure radiation safety for all corners <sup>12, 13,14</sup>.

**Fig.4. Shielding materials used in radiological facilities of Cox's Bazar district**
