Effect of Damage to the Surface of the Rollers Due to Copper Penetration in the Manufacturing Process of the Cooper Rod Using the Hot Roll Method

E.E.Susanto, F. Rahmadianto

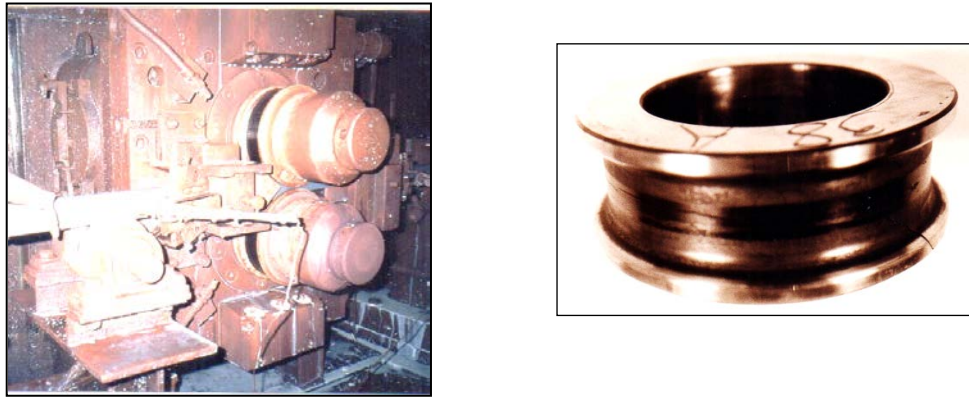
The rolled material and specifications of high quality hot work steel or chromium are suitable for hot rolling. This research was conducted on the first coils forming a cast steel rod, the rolled material has a hardness of 185 HB and has undergone heat treatment to a hardness of $\pm 51-52$ HRc and an impact force of 4.5-4.75 kp according to hot rolling standards. m / cm². Hot copper is reduced at a speed of 0.22 m / s at a temperature of 705 °C, and a reduction length of 47.36 mm.

Figure 1. Rollers for reducing hot copper

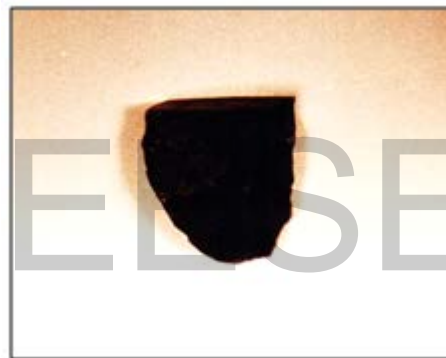
During the hot rolling process, the water mixture is cooled continuously with 2-2.5% soluble oil. Dissolved oil temperature ± 40 0C and pressure 6 kg / mm², which are used to cool and lubricate the roller surface. After the rollers are used for hot-rolling copper rods, the hardness distribution is uneven, from the specified hardness of 50-52 HRC to 45 HRC, increasing to 55 HRC. The rollers used for breakage after heat treatment are tested in the laboratory to determine the cause of the roller surface damage.

Figure 2. Roll fraction as test sample.

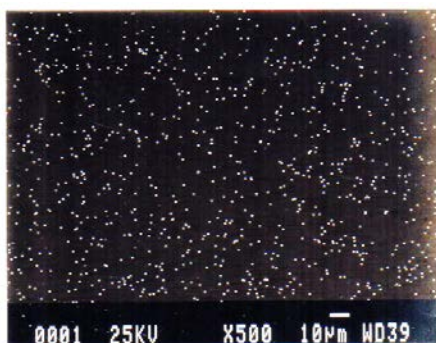
On the surface of the roller in direct contact with hot copper, copper spots are visible on the surface of the roller.

Figure 3. Copper penetration on the roller surface (raised 500 X)

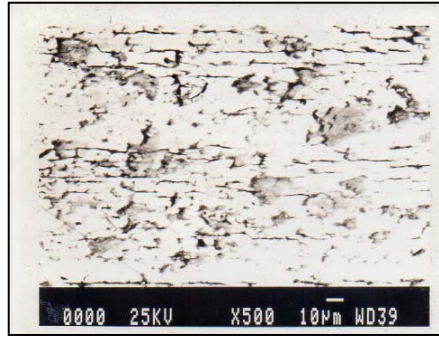
According to the roller's function of reducing hot copper, the result is small cracks or microcracks appearing on the surface of the roller..

Figure 4. Fine cracks on the roller surface (enlarged 500 X)

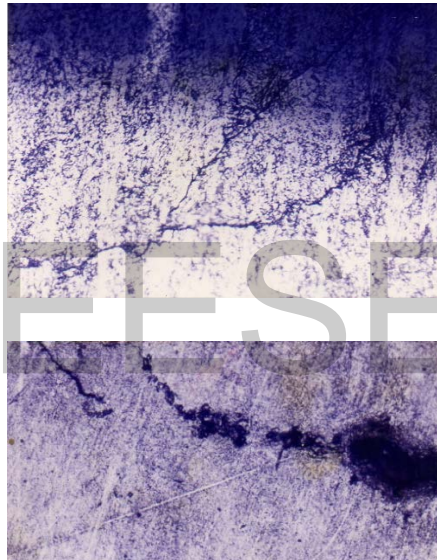
Through SEM testing on the roller surface it was found that the soft cracks spread over the entire surface, starting from the shape of the cracks, including the type of thermal fatigue. Small cracks in the roller surface take longer to propagate because the damaged roller is used continuously.

Figure 5. Cracks in the roller surface

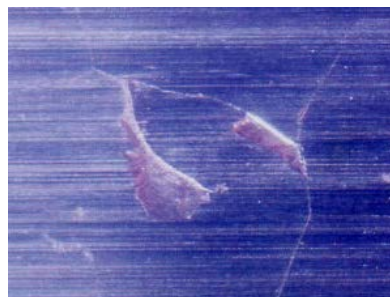
Due to hot rolling and reduced pressure on the copper rods, the surface of the roll is smooth and cracked. As a result of hot rolling with coils, small cracks continue to enlarge and expand in all directions irregularly. As a result, small holes are formed on the surface of the coils, and a copper layer is present at the bottom of the holes. The pressure to insert the copper into the roll will increase the crack speed, so the more copper penetration and deposition in the coil will accelerate the roll cracking.

Figure 6. Small holes on the surface of the rollers

With this cooling, heat transfer from the copper rod to the coiled surface can be reduced, so heat fatigue is reduced, and root surface softness can be reduced. By eliminating the difference in copper volume and penetration rate, this can be treated as one of the causes of root surface cracking. Cooling the roll surface after the rolled copper bar is heated to 705oC can reduce the deceleration time, thereby reducing surface damage.

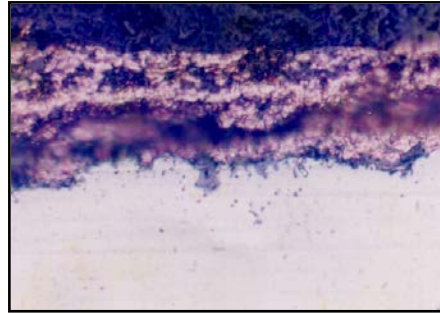
Figure 7. Copper layer at the bottom of the hole.

Since the direction of the crack may be on the right or left, penetration of the copper will result in a copper layer at the bottom of the small hole in the surface of the roll, which will cause the stress applied to the winding material to become unstable.

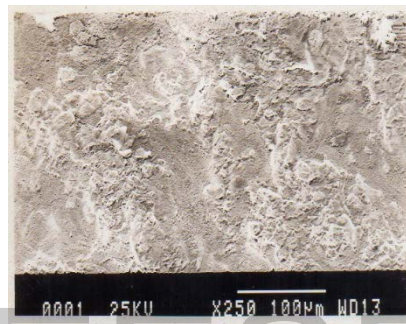
Figure 8. On the crack there is copper (enlarged 250X)

SEM testing is carried out on the part of the roller that is cracked, the copper traps that enter the crack area below the roller surface will further clarify the effect on the roller surface due to reduction of the copper rod and the direct relationship between the reduction of the roller surface and the hot copper rod. damage.

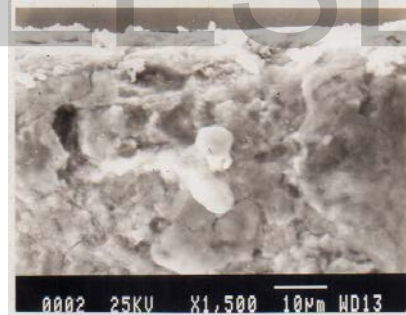
Figure 9. In the roller material there is copper (enlarged 500X)
